RADIUM-226 SOURCE REMEDIATION

Lowerline and Coolidge Streets
New Orleans, LA

A presentation for the City of New Orleans

January 18, 2019

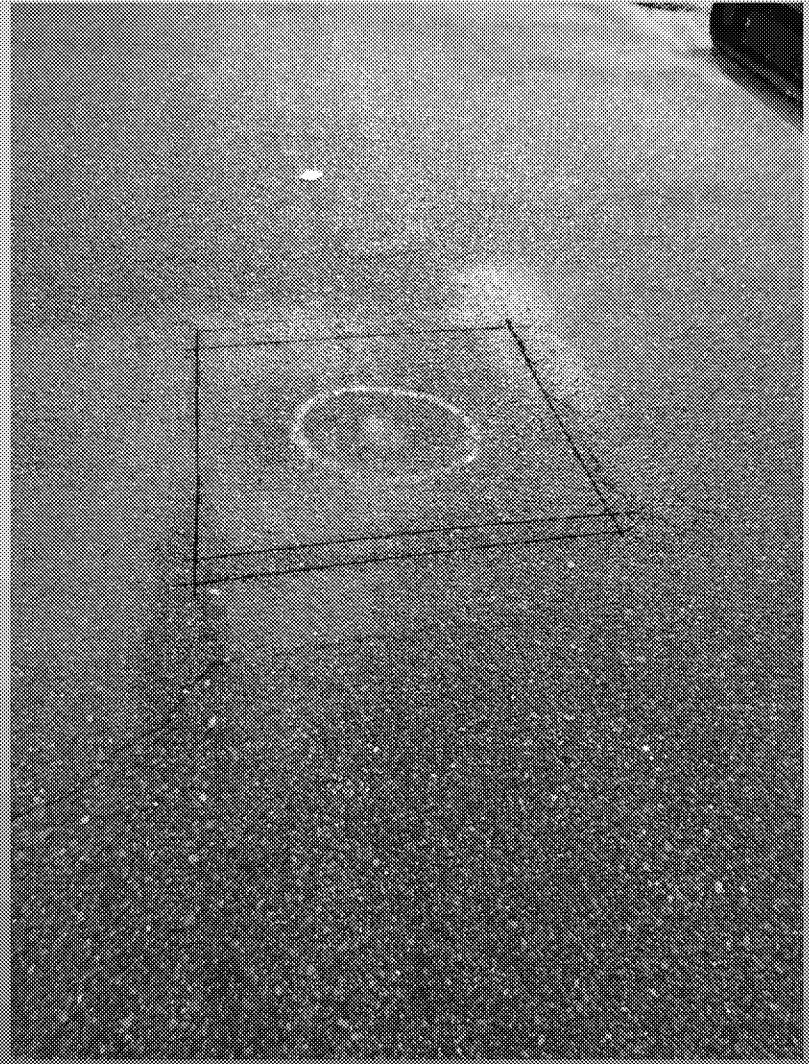
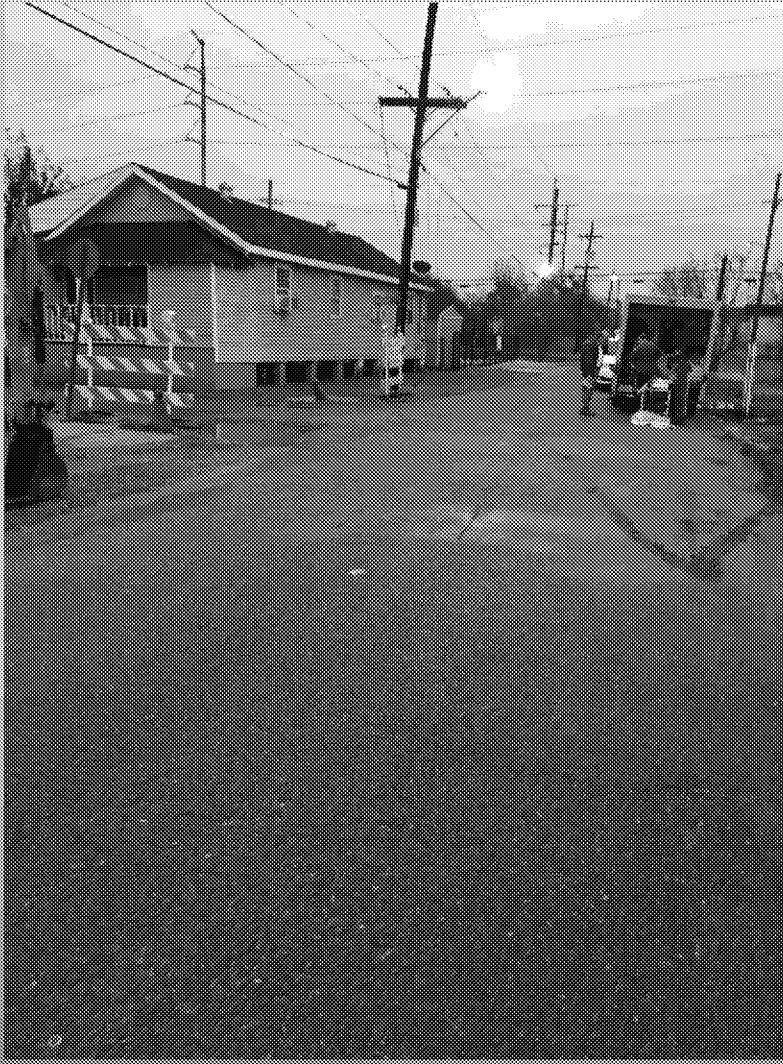
DESCRIPTION OF PHASE 1 ACTIVITIES

- Concrete saw used to cut asphalt approximately 3'x3' around the location.
- Air sampling in and around the work area conducted.
- Mini-Excavator used to removed asphalt and set aside. Surveyed and released as clean.
- Subsurface material removed in lifts, surveyed, and placed into prepared drums.
- Excavation to a depth of approximately 24—30 inches.
- Material screened visually and with dose rate meter for “source”.
- Magnitude and extend found exceeded scope – excavation halted.
- Samples collected of 3 drums of material and excavation at completion.
- Excavator bucket successfully decontaminated and released.
- Equipment and material surveyed and released.
- Drums closed, labeled, and shipped by DOT hazmat carrier to Port Allen.
- Demobilization

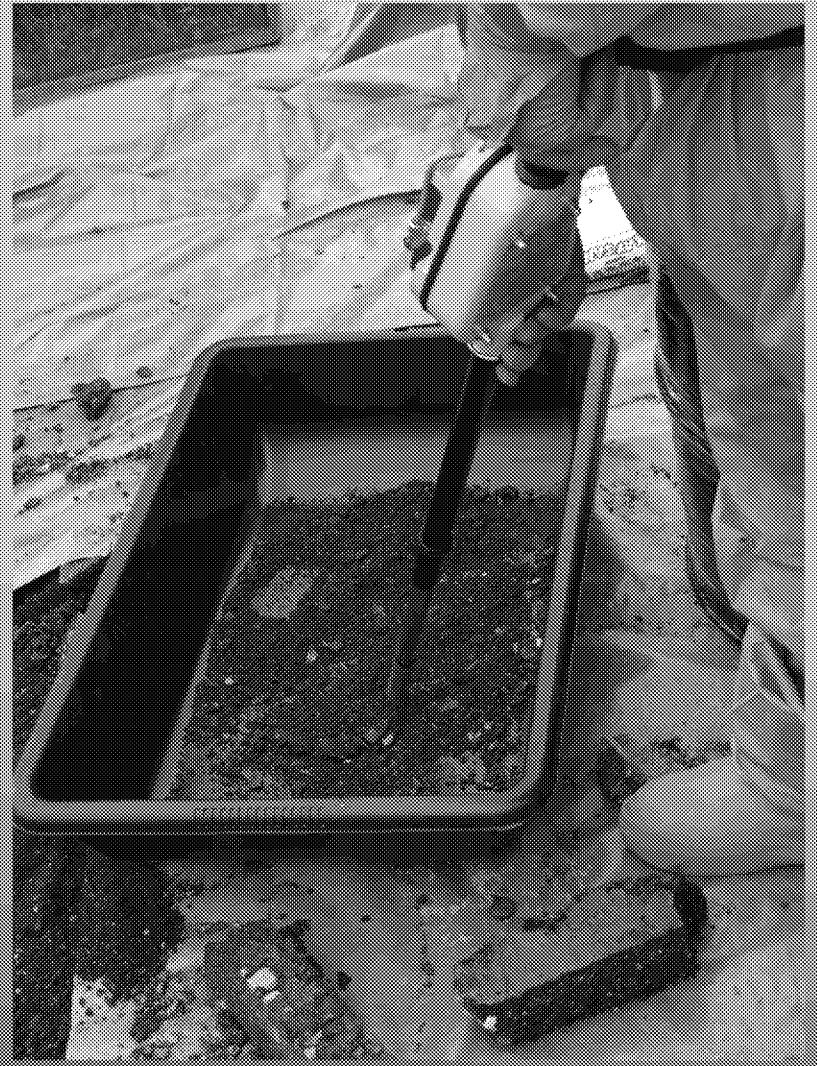
DISCOVERIES DURING PHASE 1

- ▶ Contamination appears to be below 2nd layer of asphalt. It is intermingled with and below a layer of crushed oyster shell roadbase.
- ▶ No “source” or obvious source capsule was discovered during excavation.
- ▶ Localized rate incrementally increased from 1.5 mR/hr to 10,000 mR/hr during excavation.
- ▶ General Area dose rates exceeded posting requirements and required the radiological area to be broadened.
- ▶ Significantly elevated alpha contamination levels were discovered in the excavation.
- ▶ Removable contamination in excess of release limits was detected on the bucket and surrounding plastic.
- ▶ Contamination appears bound to the soil. Decontamination was achieved after removal of soil from equipment and excavator.

- ▶ 10,000 mR/hr “source material” identified, bagged, contained, wrapped in 2 layers of lead blankets, and placed into the center of a sand filled 55-gallon drum for transport to Port Allen.
- ▶ Contact dose rate 53 mR/hr.
- ▶ Other contaminated soil drums range from background to 38 mR/hr.
- ▶ Significant contamination remained after excavating 24-30” ($>2.5\text{MCPM}$, 5 mR/hr).
- ▶ There was an unknown metallic cable/debris discovered in the bottom of the excavation.
- ▶ Several other areas of elevated dose rate were discovered around the original location.
- ▶ After consultation with NOLA and LDEQ, the excavation placed in a safe configuration (decontaminated, equipment released, waste removed, backfilled, and cold patch applied).

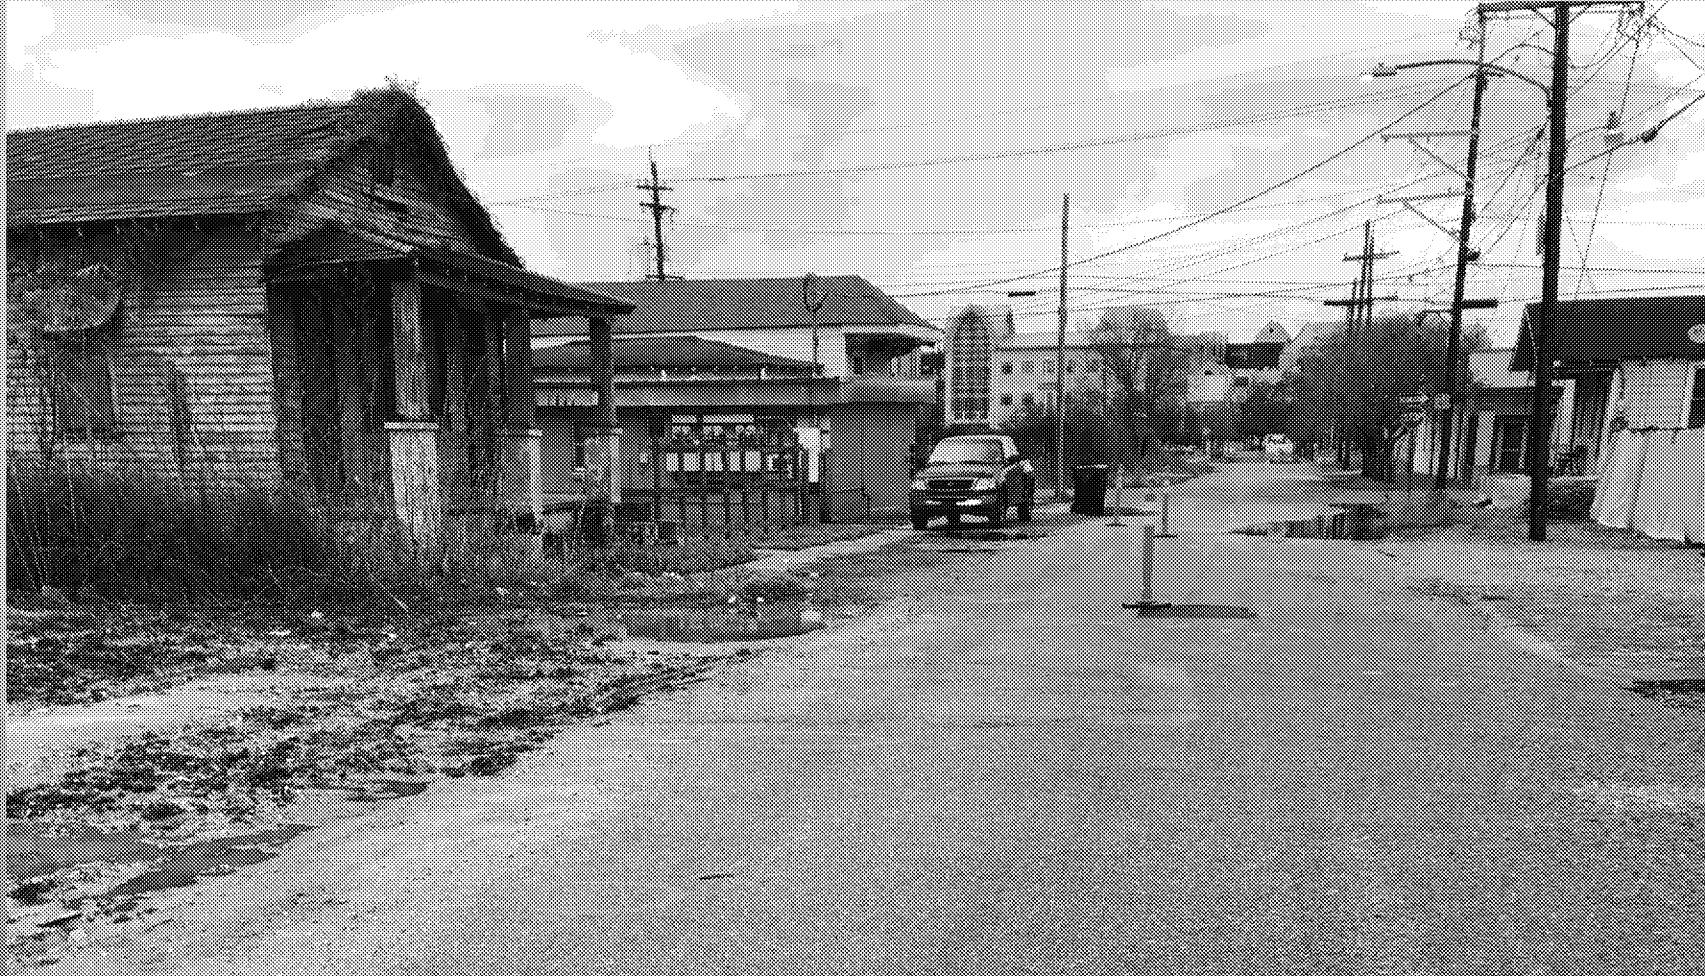
RESULTS OF GAMMA WALKOVER SURVEY

- ▶ Gamma Walkover Survey was performed on December 3, 2018.
- ▶ Lowerline Street from Edinburgh to Olive and portions of Coolidge was surveyed.
- ▶ Survey parameters and methodology:
 - ▶ 2x2 inch sodium iodide with lead collimator/shield – very sensitive to gamma radiation emitted by Ra-226.
 - ▶ Positioned 4 inches off the ground.
 - ▶ Transitioned linearly at 1-1.5 feet per second.
 - ▶ Radiation levels are recorded each second along with position.
 - ▶ Positional information collected using Trimble GPS.
 - ▶ Accuracy within 24".
- ▶ Survey revealed multiple areas of elevated dose rate along Lowerline Street.
